# London Borough of Camden Section 19 Flood Investigation Report

Flood Incidents on the 12<sup>th</sup> and 25<sup>th</sup> July 2021

Project number: 60672596

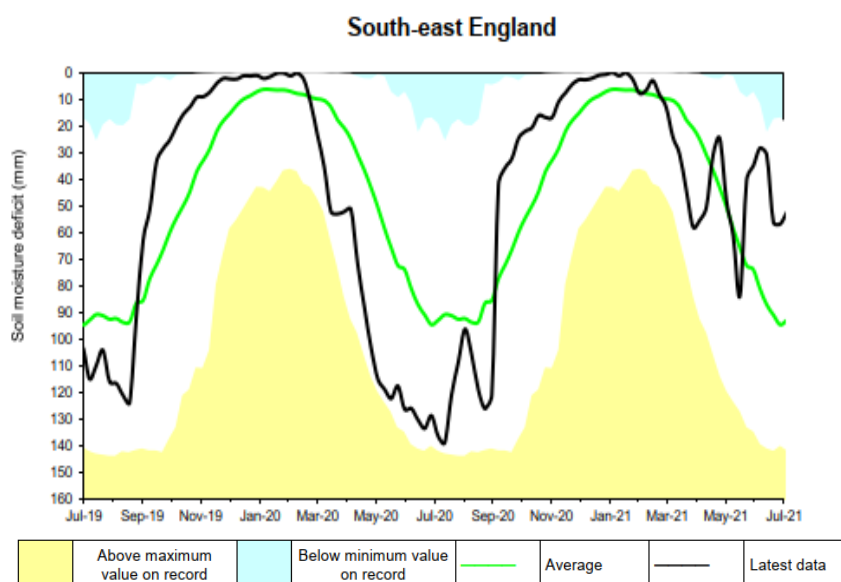
**Figure 3-2: Soil Moisture Deficit for South East England**

At the end of July soil moisture deficit (SMD) values were less than the Long Term Average (LTA) for the period 1961-1990 for the time of year across South east England (soils were wetter than the LTA). The SMD for mid-July was approximately 40mm, much wetter than the average (by approximately 50mm) for this time of year; as presented in **Figure 3-2**.

*compared to the maximum and minimum, and 1961 to 90 long term average*

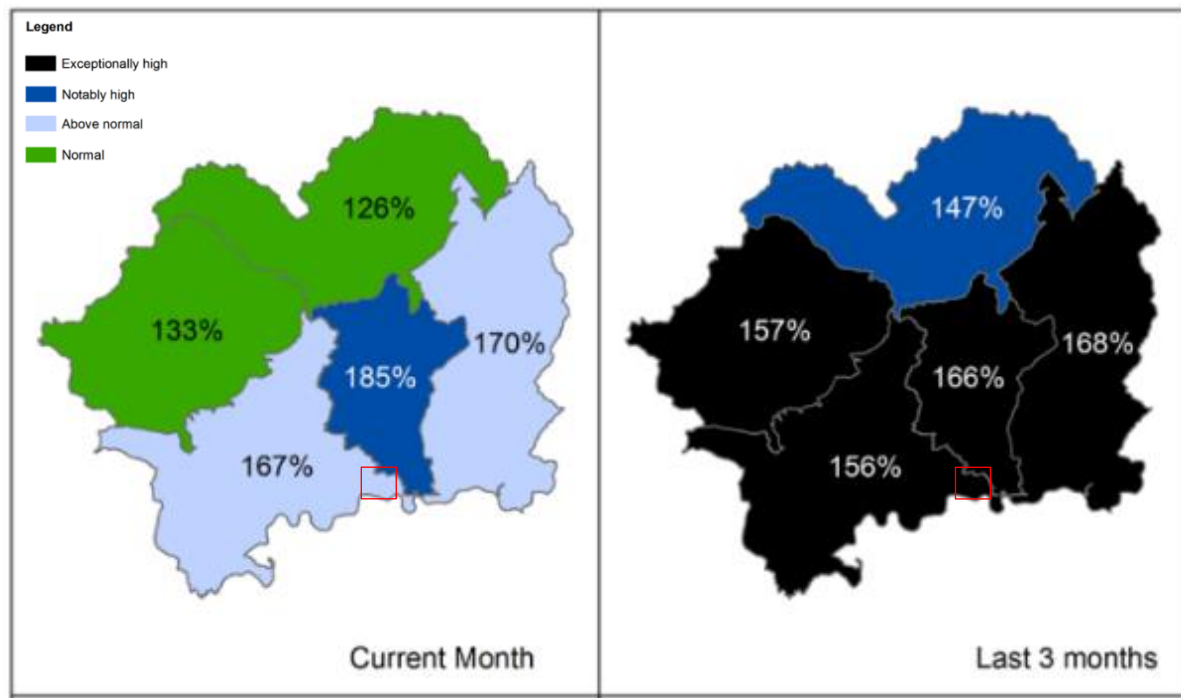
**Figure 3-3: Total Rainfall in July across Hertfordshire and the North London Area**

The EA water situation report illustrates that July 2021 was a wet month for this area with multiple intense thunderstorms, which led to high daily rainfall totals. Rainfall on both the 12<sup>th</sup> and 25<sup>th</sup> of over 60 mm was observed in several locations in North London and the surrounding catchments<sup>17</sup>.

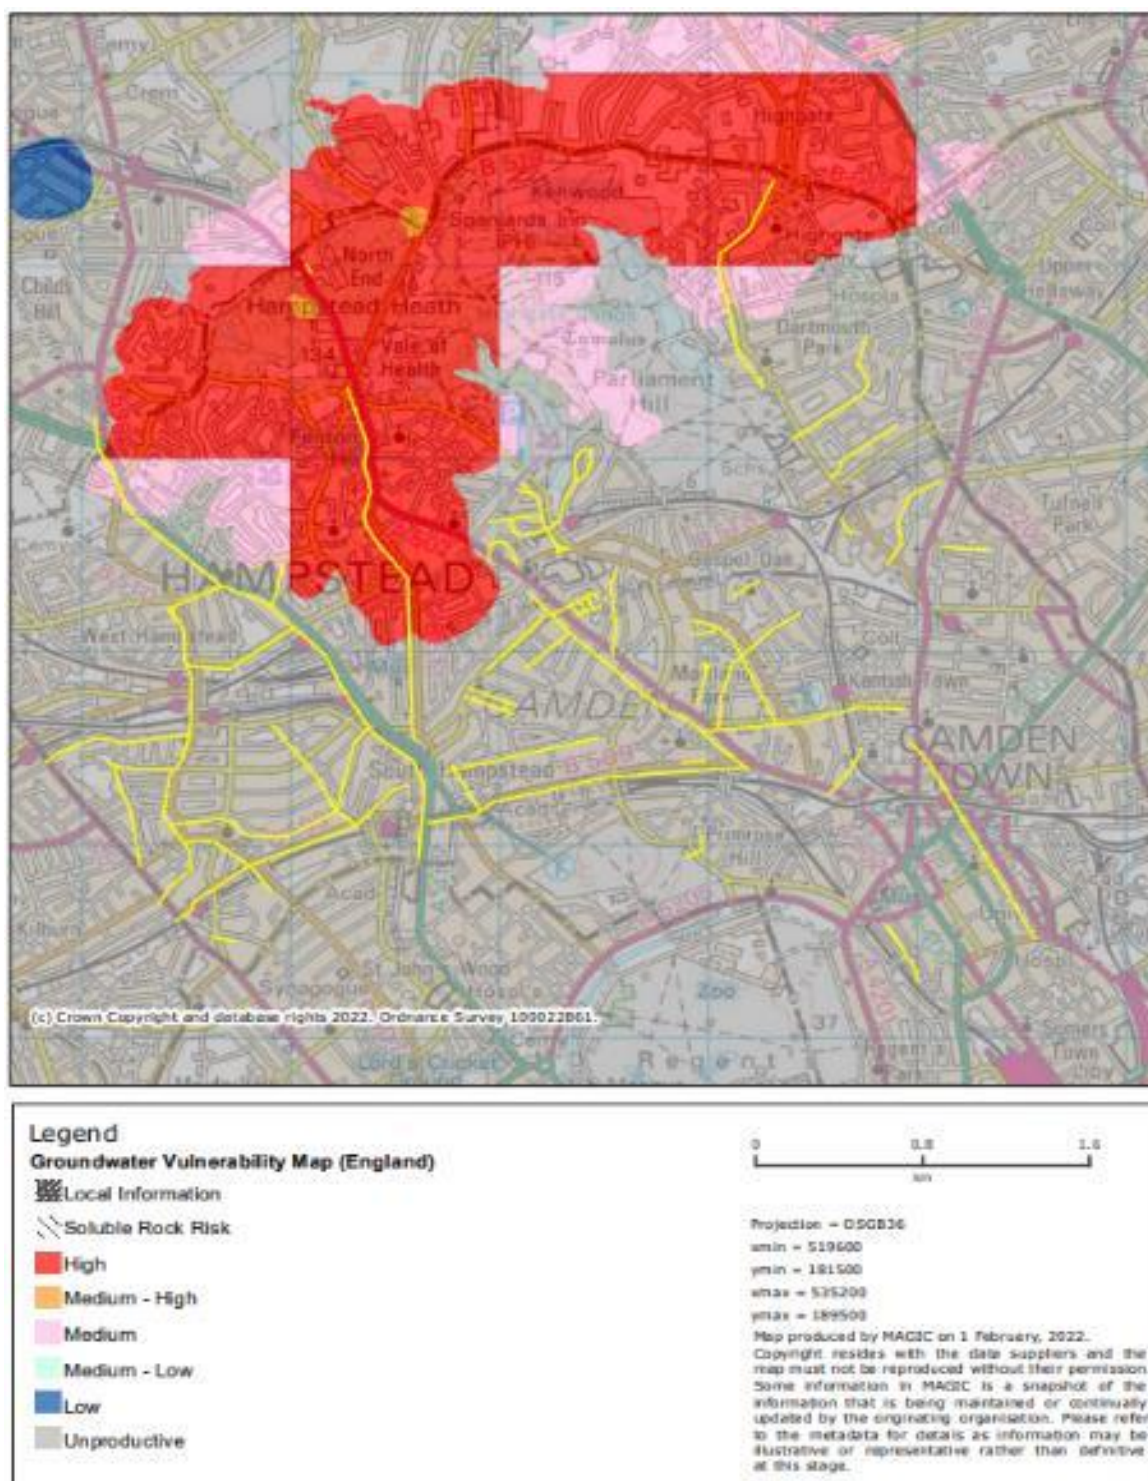
Figure 3-4: Groundwater Vulnerability Map and Flooded Street Locations

Geology and soil mapping shows an area of Secondary A aquifer north of Camden, which has a high vulnerability to groundwater flooding. Reports of flooding have been recorded in this area, as shown through the flooded street data, as presented in **Figure 3-4**. Sewer mapping provided by TW confirms the gravity sewer network in this area follows the street layout.

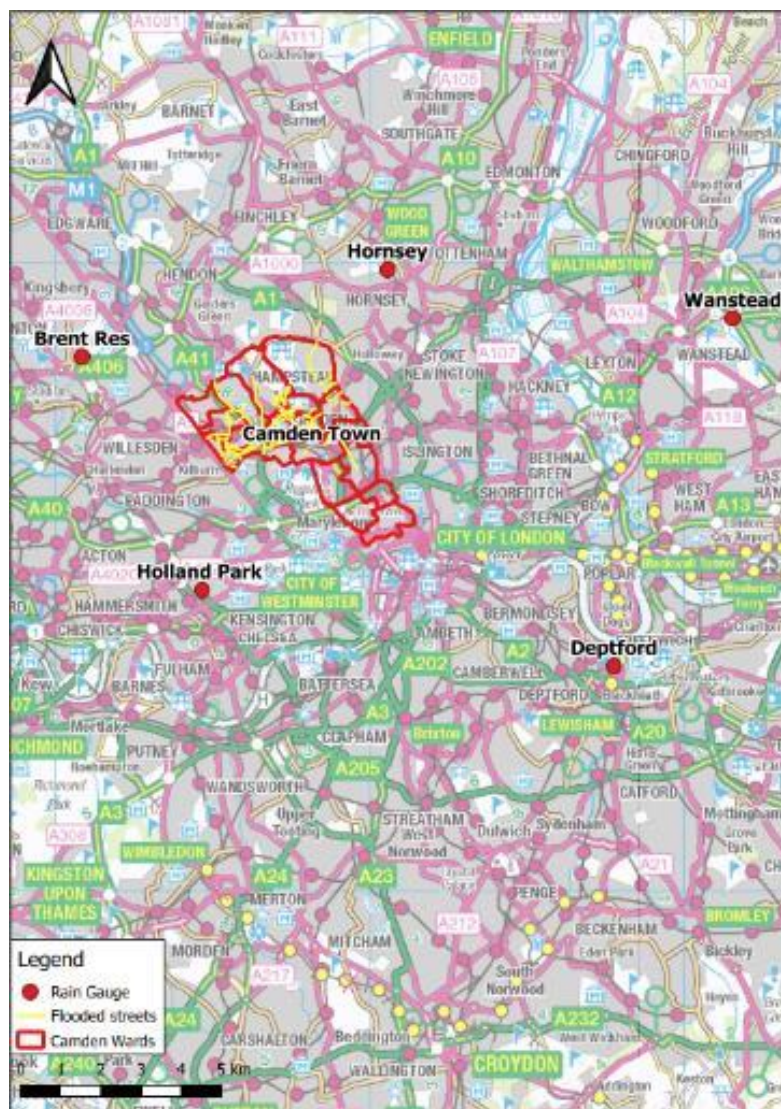
Figure 3-5: Rain Gauge Location Map

The largest observed daily total (cumulative 15 min rainfall data) of 68.4 mm was recorded at Holland Park on the 12<sup>th</sup> July, while Wanstead recorded a daily total of 54 mm on the 25<sup>th</sup> July. The other nearby rain gauges recorded lower totals highlighting the spatial variation of the rainfall experienced during this event. The daily rain gauge at Deptford recorded very little rainfall on the 12<sup>th</sup> July and a low return period total on the 25<sup>th</sup> July events and has therefore not been included in the analysis.

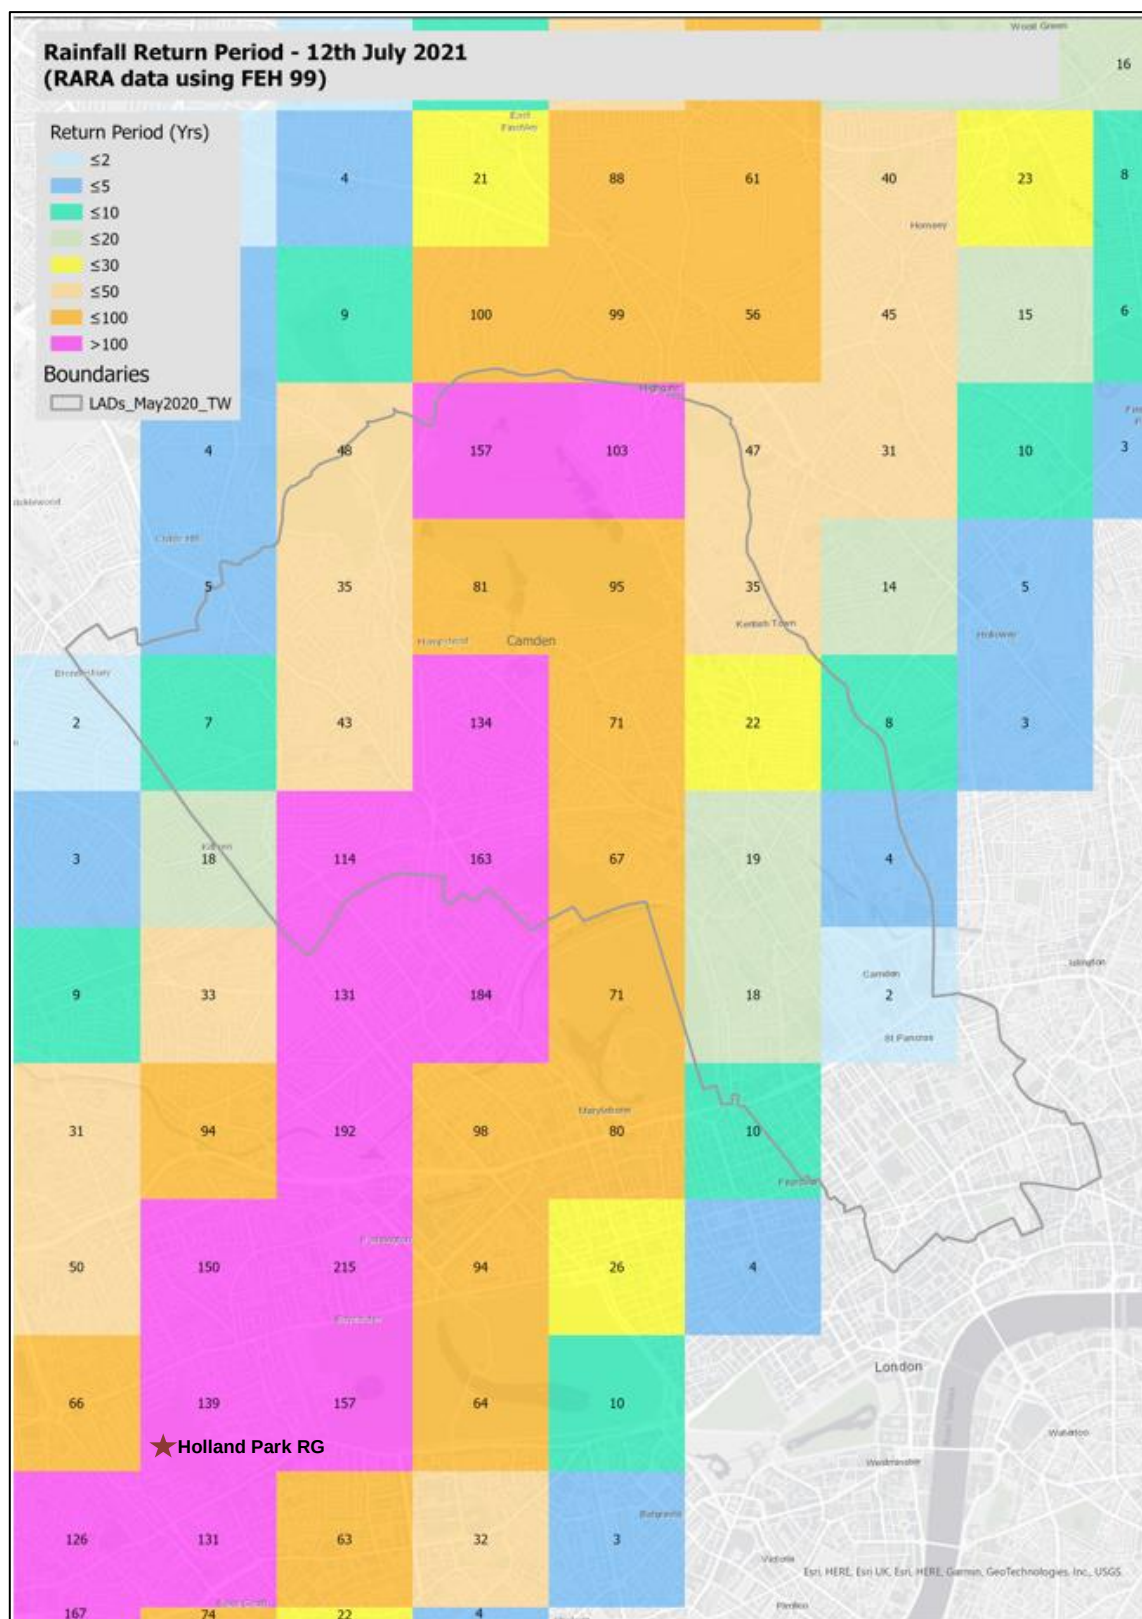
Figure 3-6: Thames Water Rainfall-Radar Return Period Analysis (12<sup>th</sup> July 2021)

**Figure 3-6** highlights the spatially variable nature of the rainfall during the 12<sup>th</sup> July event, with the highest return period rainfall occurring in a narrow band stretching from the eastern wards of Camden Town, towards the north western corner over Hampstead. The Holland Park rain gauge overlaps with this band of heavy rain, however the return period estimate based on the rain-radar image is much higher (139 year) than that observed at the rain gauge (17 years observed, 31 years corrected). The radar image has a resolution of 1km<sup>2</sup> so it is possible that the actual rainfall distribution within this grid square missed the Holland Park rain gauge.

Without access to the rainfall-radar data it is not possible to independently confirm the return period estimates provided above, or assess the methods used (i.e. choice of using FEH99 when FEH13 would be the most up to date dataset). However the above mapping is useful to illustrate the spatial variation and highly localised nature of the rainfall over Camden during the 12<sup>th</sup> July event. The 25<sup>th</sup> July mapping supports the lower rainfall totals observed near to Camden during this event. A check was carried out using the Holland Park observed rainfall assessing the difference in return period estimation using the FEH99 and FEH13 rainfall datasets. The comparison resulted in a 2 year difference in return period estimate, therefore the influence on return period of using either dataset in this area should be marginal.

The return period analysis discussed above was determined using FEH methods and observed rain gauge data (1 in 23 years for 12<sup>th</sup> July and 1 in 50 years for the 25<sup>th</sup>) is much less than that reported by TW which shows rainfall-radar return periods exceeding the 1:100 year in Camden on the 12<sup>th</sup> July. It is likely that the localised nature of this rainfall event resulted in the highest rainfall intensities missing the physical rain gauges. The rainfall-radar analysis indicates that the highest return period rainfall occurred in a band stretching from the eastern Camden wards, towards the north western corner covering Hampstead (with a range of 67 – 163 year rainfall return period), this band of rainfall corresponds with the areas that experienced the most flooding, indicating that these high rainfalls return period estimates are accurate.

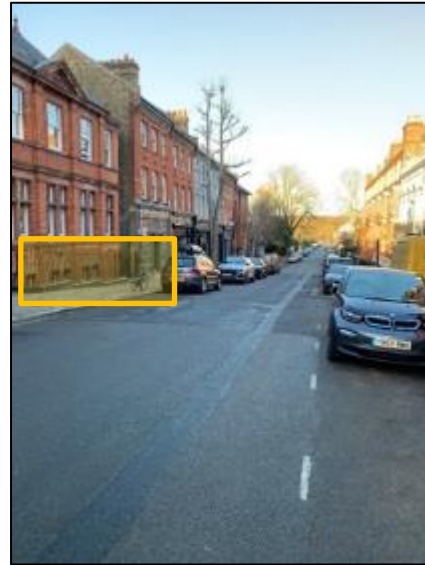
**Photograph 38**

presented in **Photograph 38**. These properties may be more susceptible to ingress in the event of water levels exceeding kerb height.

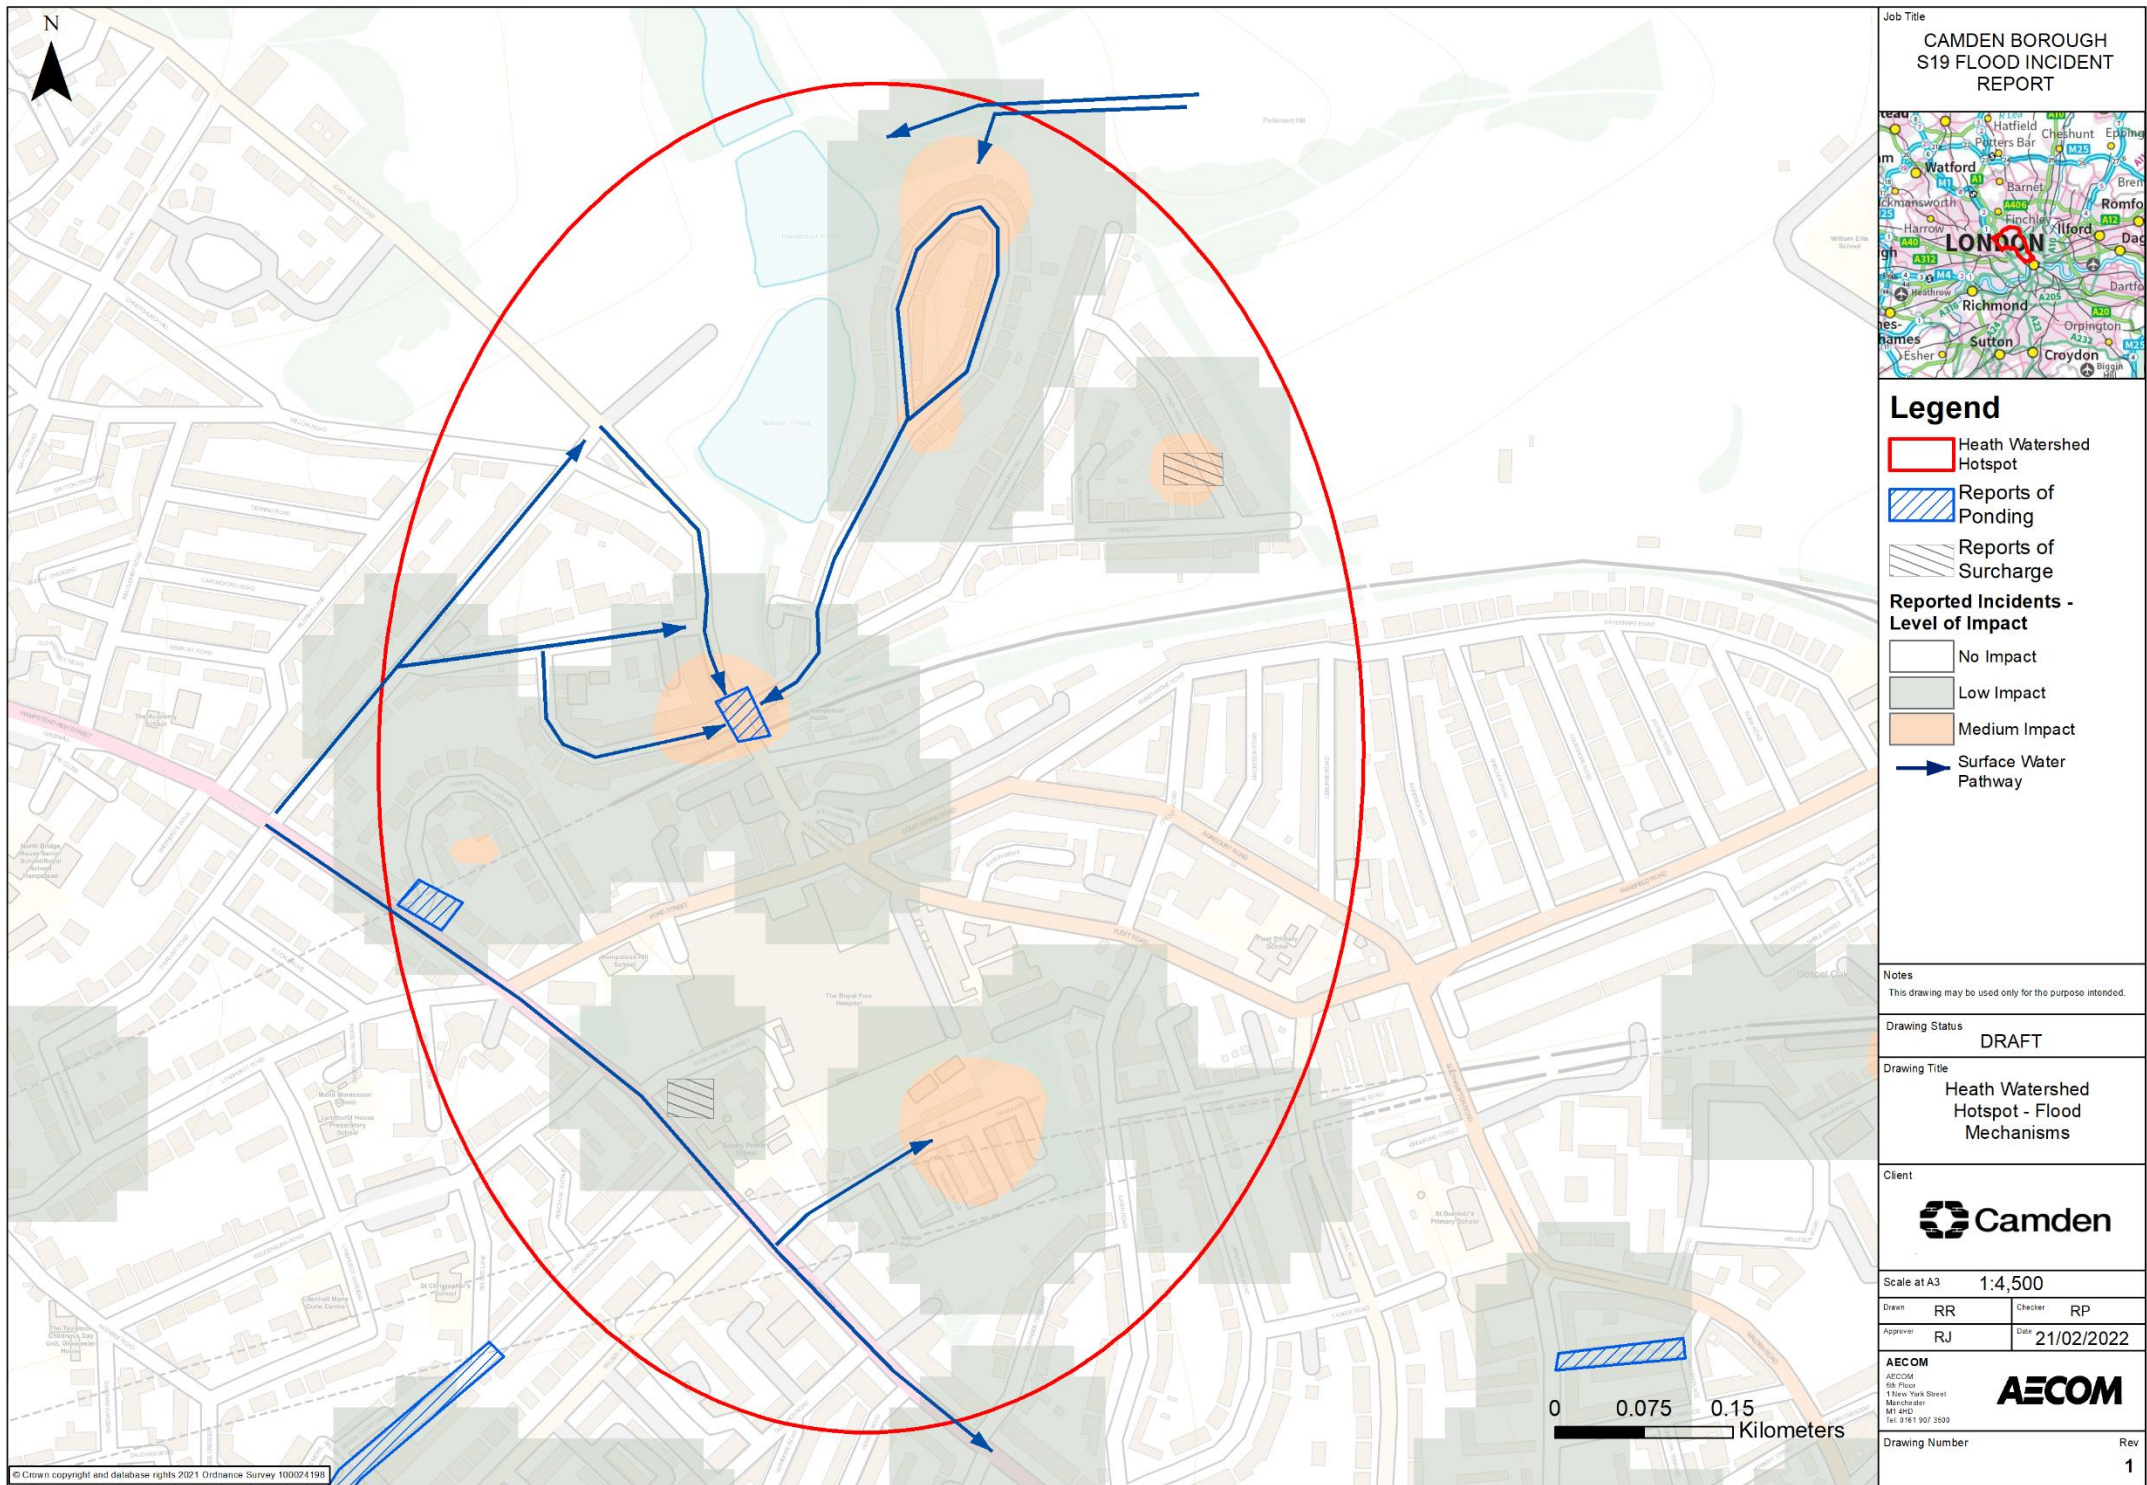
Figure 4-8: Heath Watershed Hotspot - Flood Mechanisms

- Site observations and anecdotal evidence indicate surface water is the predominant driver for flooding on the 12<sup>th</sup> and 25<sup>th</sup> July. However, TW records indicate there were reports of surcharging drainage assets on Haverstock Hill (25<sup>th</sup> July) and east of the areas of interest (12<sup>th</sup> July). This indicates the drainage capacity was exceeded due the rarity of the rainfall, leading to surcharge of drainage assets. A visual representation of the flood mechanisms is presented in **Figure 4-8**.

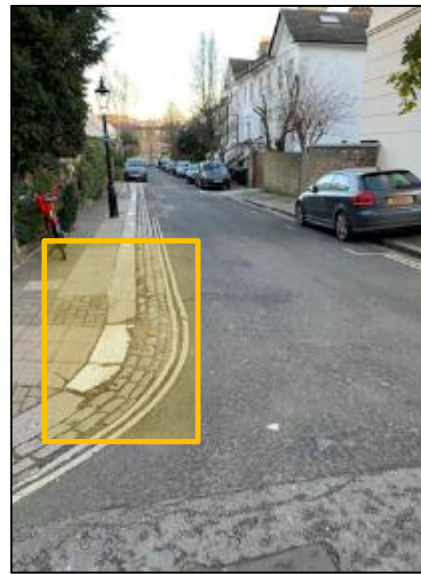
**Photograph 45**

The kerb height varies, with sections of the kerb at road level; this is presented in **Photograph 45**. At these locations, surface water is likely to transfer to the footpath. A large proportion of property thresholds are level with the kerb height, therefore there is potential for surface water to approach the threshold. However, several of the properties are bounded by a wall, which may act as a barrier and reduce risk.

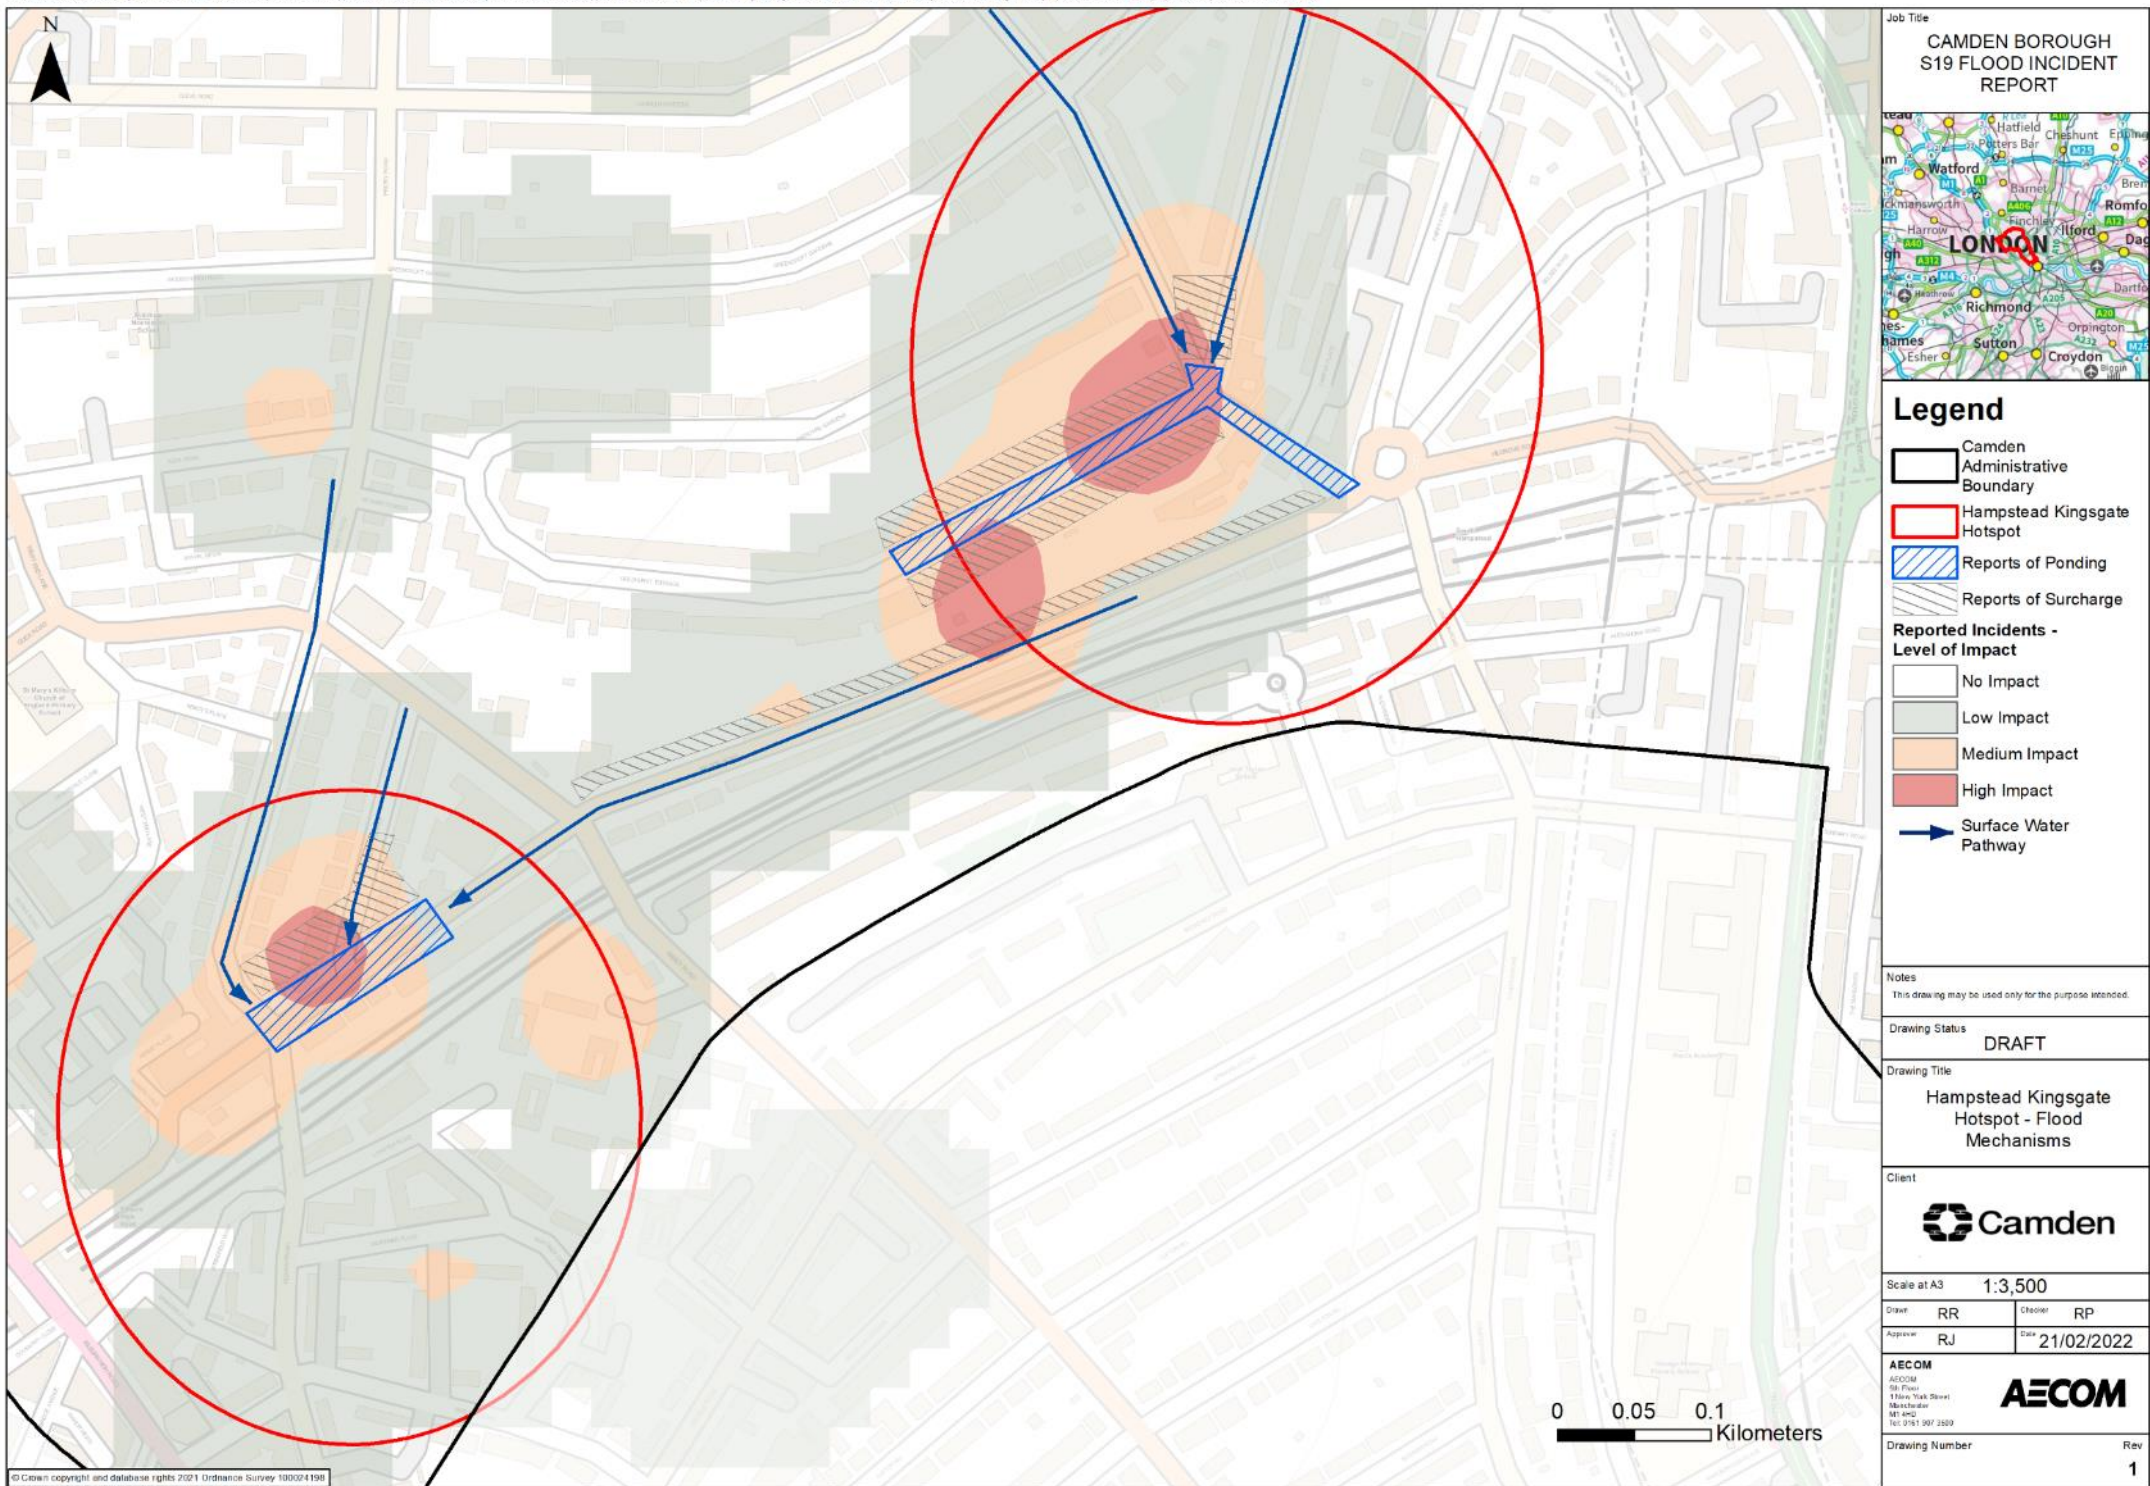
Figure 4-21: Hampstead Kingsgate Hotspot - Flood Mechanisms

- A visual representation of the flood mechanisms is presented in **Figure 4-21**.

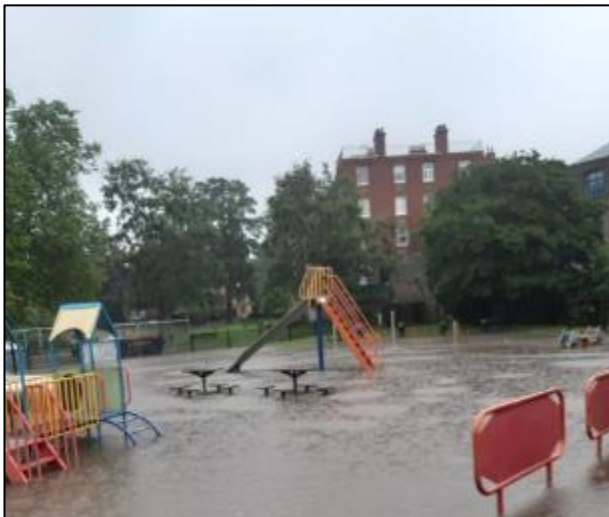
**Photograph 94**

It was observed from the site visit that the playground and Attendant's Building is situated within a localised area of low elevation, at the base of several small slopes found within the within the Kilburn Grange Park greenspace. Surface water flows are likely to be conveyed to the low elevation and accumulate on the playground, which is partly formed of impermeable material. There are no incident records to indicate the neighbouring Primary School flooded on the 12<sup>th</sup> or 25<sup>th</sup> July 2021.
